Industry & Facilities Division 3° Party Shop Inspection Services		
Inspection Report N°: 4083	Date of issuance:	20.10.2016
🗆 Initial	Interim	✓ Final
Rev. n°:	Reason of revision:	
Inspection requested by: AIRONN HAVA	LANDIRMA VE KLİMA SİSTEML	.ERİ SAN. DIŞ TİC LTD ŞTİ
BV Inspection performed as Recognized	Authority: 🗹 No 🛛 Yes	(specify what recognition)
P/o nr: IDD.TR.2488737.A41	P/o nr: N/A

MATERIAL / SUPPLY / SUBJECT OF INSPECTION	ITEM / TAG Nr	QTY
3rd Party Inspection of Actuated Cabinet Roof Type Axial Smoke Exhaust	AIR-A-U-1250	1
Fan

INSPECTION REPORT N° 4083

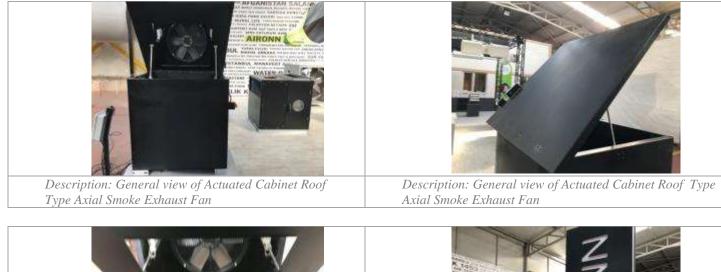
Description: General view of Actuated Cabinet Roof Type Axial Smoke Exhaust Fan

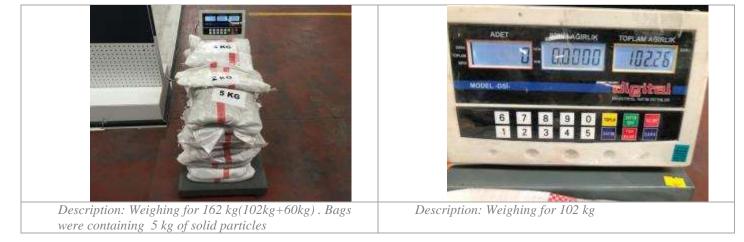
Description: Weighing for 162 kg(102kg+60kg).Bags were containing 5 kg of solid particles

Description: Weighing for 60 kg

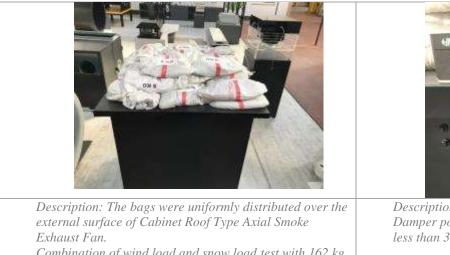
Combination of wind load and snow load test with 162 kg during 10 minutes.

Description: Damper tested 1 time with unloaded. Damper position was reached at fire operating position less than 30 second after 10 minutes.

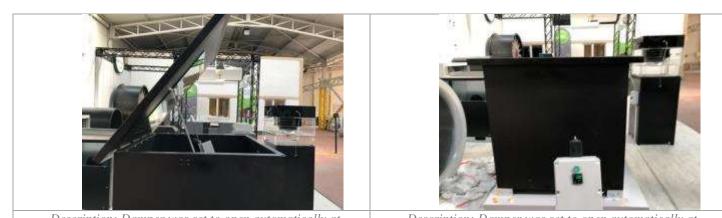
Description: Damper was set to open automatically at 5000 time.

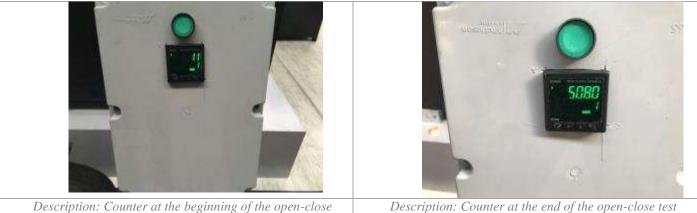
Description: Counter at the beginning of the open-close test

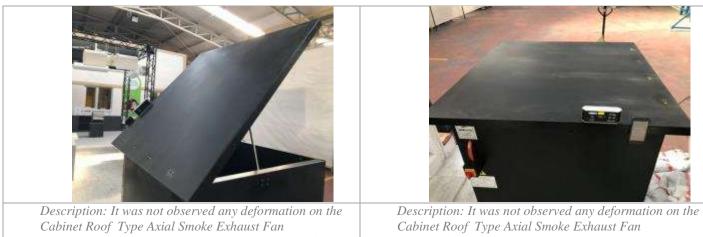
Results were found satisfactory It was not observed any deformation on the Actuated Cabinet Roof Type Axial Smoke Exhaust Fan after Combination of wind load and snow load test and open and close test.

After Combination of Snow load test and Wind load test and open-close test
